SEFA 8.0 CABINET SURFACE FINISH TESTS

Item Tested: Basic Material / Solid Material PEHD-EL High-Density Polyethylene Electrically Conductive

Reference: Scientific Equipment & Furniture Association (SEFA)
Laboratory Furniture Casework, Shelving and Tables Recommended Practices
SEFA 8-PL 2014

Section 8.0 Cabinet Surface Finish Tests

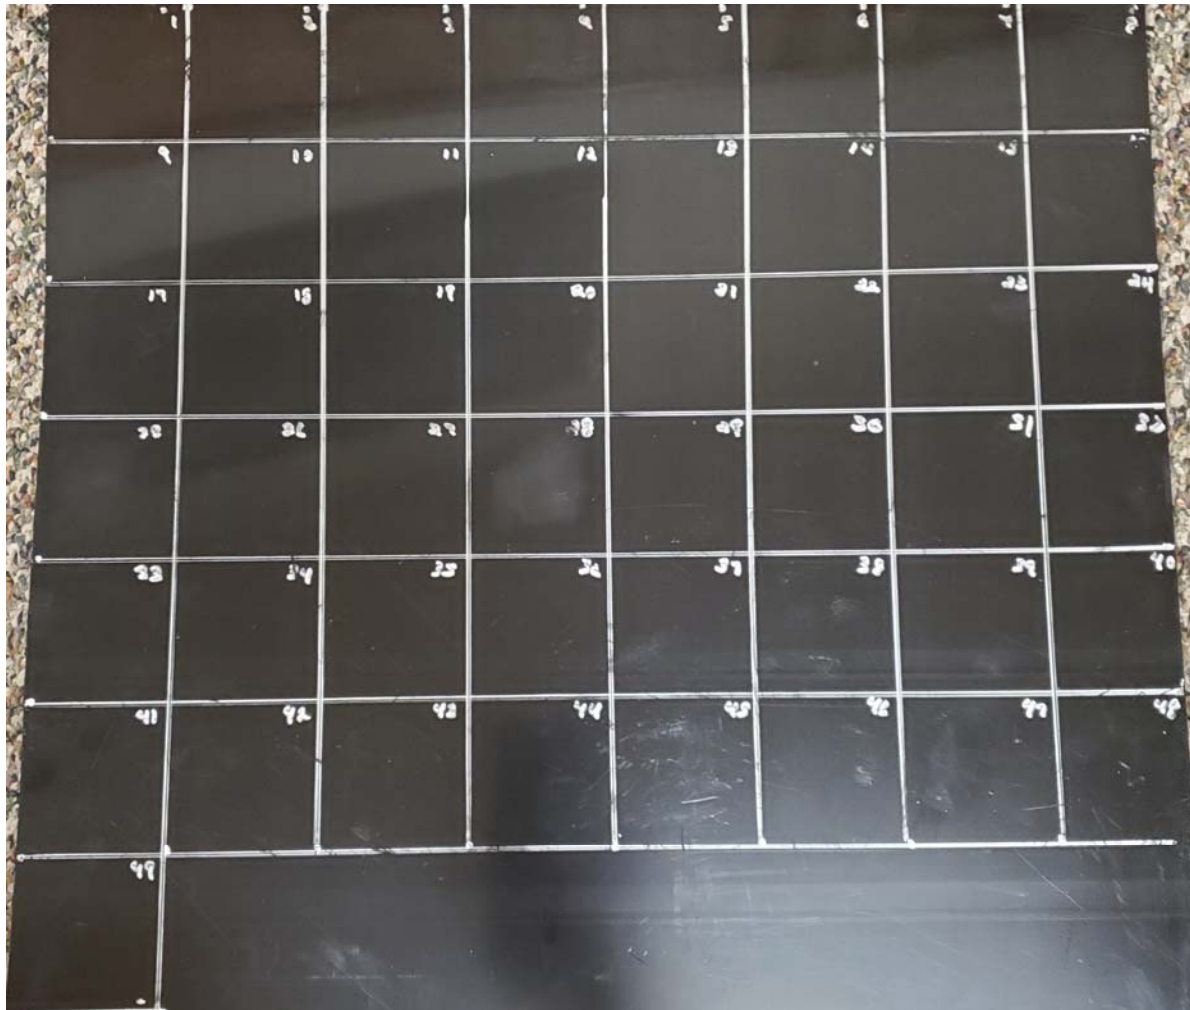
SEFA 8

Basic Material / Solid Material PEHD-EL High-Density Polyethylene Electrically Conductive
